The State of Our Streams: 2011

2011 Water Quality Index, City of Durham:

Ellerbe Creek Watershed (Neuse River Basin)

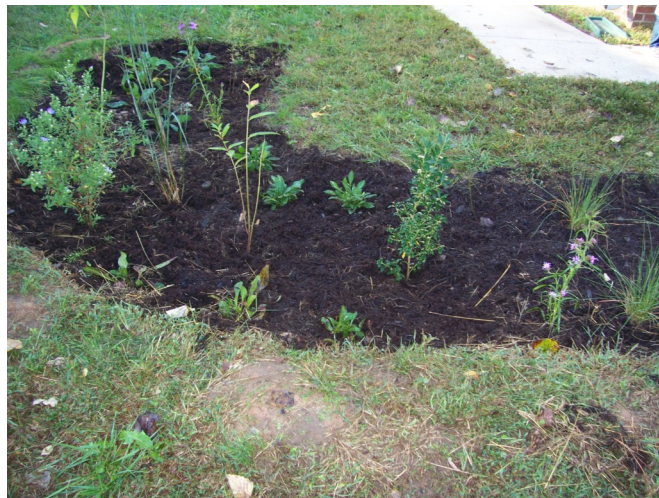
Completed residential rain garden by local youth under Mayor's summer youth work program

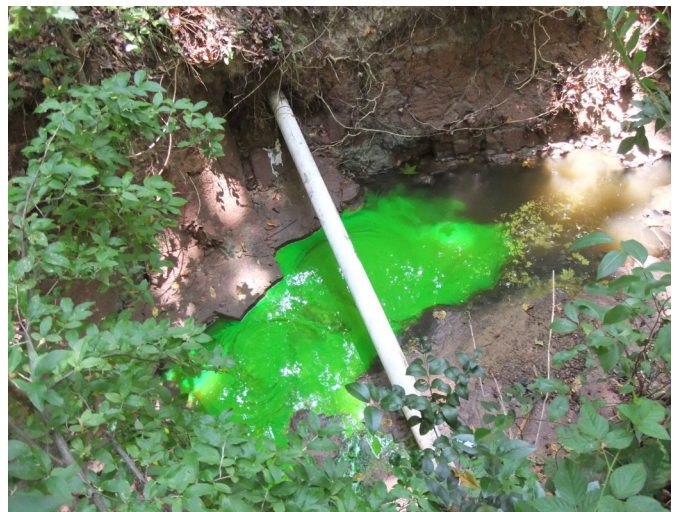
Dye-testing for sewer lateral break in a tributary of Northeast Creek

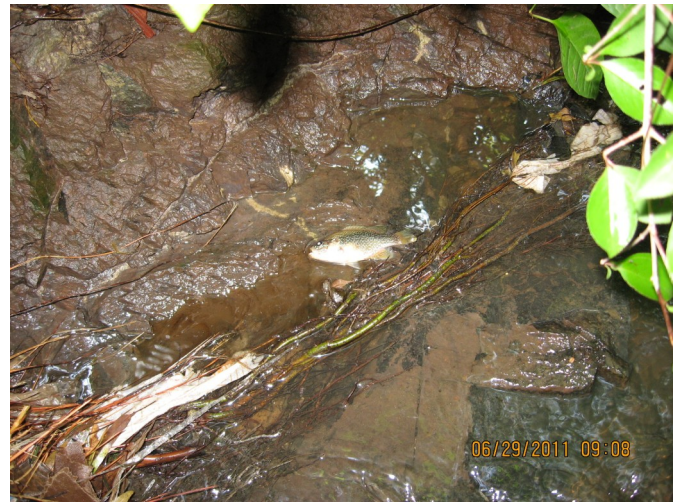
Minor Fish Kill due to gasoline spill in June 2011 in a tributary of Ellerbe Creek

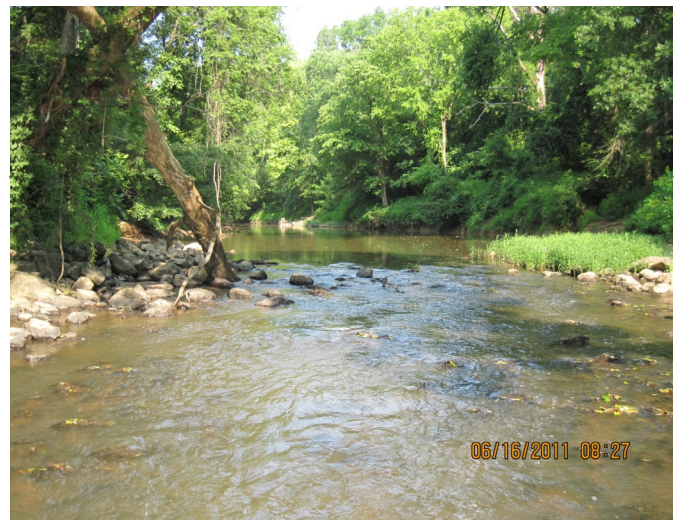
Eno River at Snow Hill Road, an aquatic life (benthic macroinvertebrate) sampling site

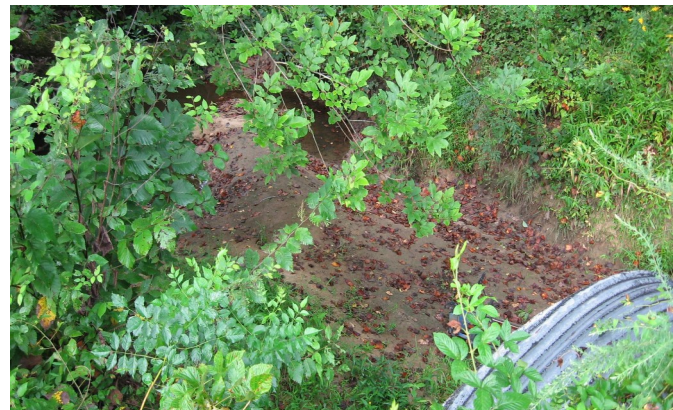
Panther Creek under dry conditions

This is a relatively small watershed and the stream frequently goes dry. No samples could be collected from August through October of 2011. Because of its small size and tendency to dry up, Panther Creek is heavily influenced by the change in seasons.

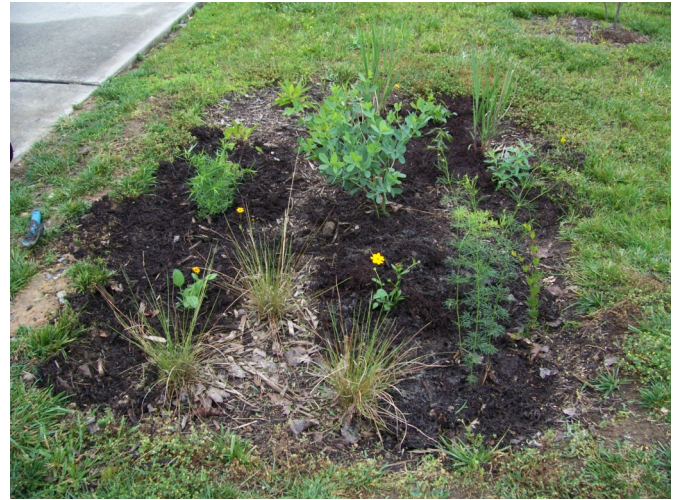
Installed residential rain garden in Northeast watershed

Stormwater Services completed installation of sixteen residential rain gardens on twelve properties in 2011. The residential rain garden program received a great response from residents. The project was funded by a section 319 grant.

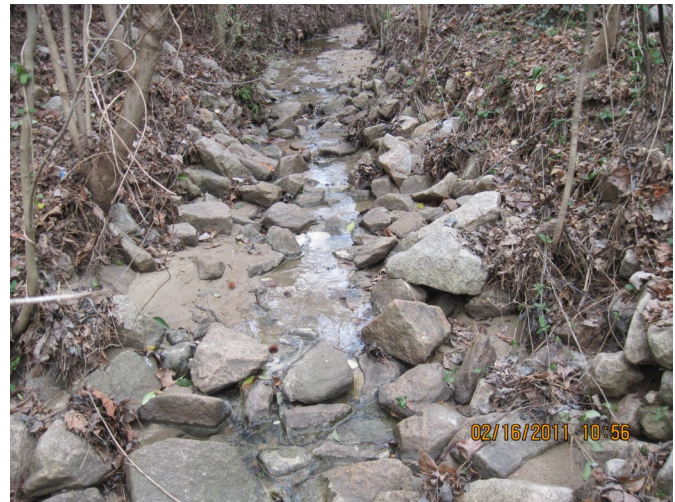
Illegal Paint Discharge in Tributary of Third Fork Creek at Rockwood Park
